Manhole Inspection Summary

Manhole # S33E__039MH

Insp Date: **8/4/08 11:33 AM**

Location Address: **101 w lexington st**

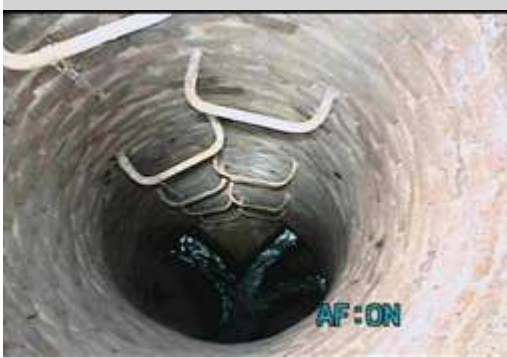
Defect 2

Count: **9** Missing: **0** ☒ **Corroded**

steps

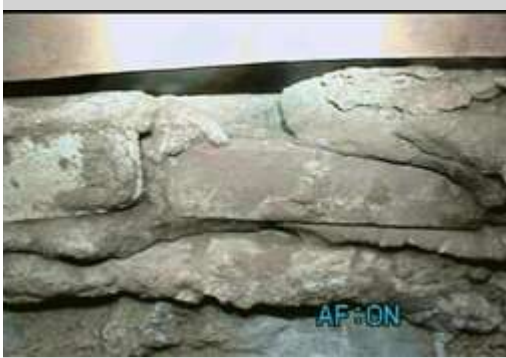
Defect 1

Condition: ☐ Sound ☒ **Cracked** ☐ Root Intrusion ☐ Loose Brick ☒ **Deteriorated**

chimney cracked & deteriorated

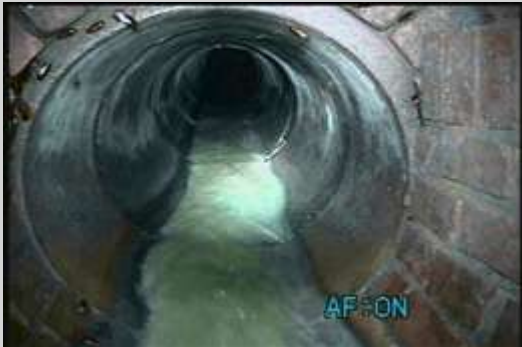
12 O'Clock Outflow

18 in. Circular Gravity Sewer
Pipe Out @ 12 O'Clock

Pipe Material: **Clay** ☐ Pipe Lined

Invert Depth: **16.55** (ft.) Flow Characteristics: **Fast**

Infiltration: **None** Pipe Seal Cond: **Unknown**

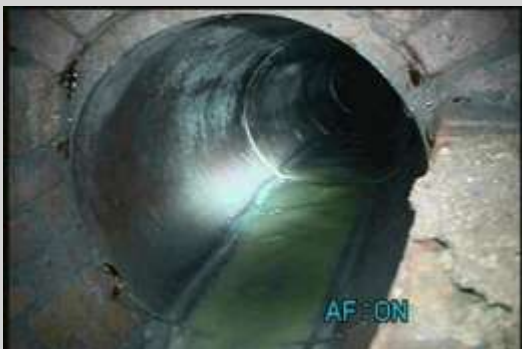
3 O'Clock Inflow

18 in. Circular Gravity Sewer
Pipe In @ 3 O'Clock

Pipe Material: **Clay** ☐ Pipe Lined

Invert Depth: **16.50** (ft.) Flow Characteristics: **Fast**

Infiltration: **None** Pipe Seal Cond: **Unknown**

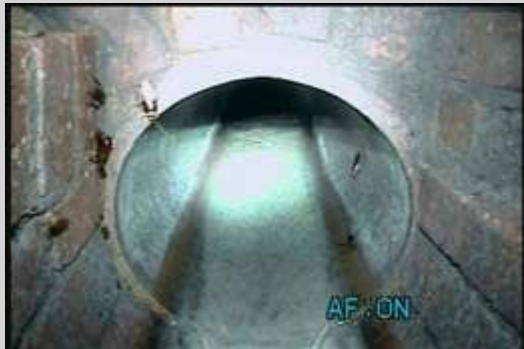
7 O'Clock Inflow

10 in. Circular Gravity Sewer

Pipe In @ 7 O'Clock

Pipe Material: **Clay** ☐ Pipe Lined

Invert Depth: **16.52** (ft.) Flow Characteristics: **Fast**

Infiltration: **None** Pipe Seal Cond: **Unknown**

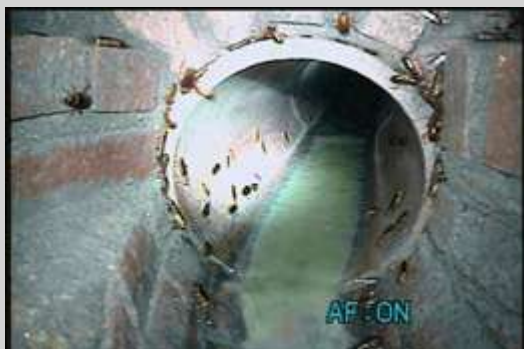
9 O'Clock Inflow

10 in. Circular Gravity Sewer

Pipe In @ 9 O'Clock

Pipe Material: **Clay** ☐ Pipe Lined

Invert Depth: **16.25** (ft.) Flow Characteristics: **Fast**

Infiltration: **None** Pipe Seal Cond: **Unknown**
